CALSPAN ADVANCED TECHNOLOGY CENTER

IMPROVED LIGHTWEIGHT SUBCOMPACT
SIDE STRUCTURE CRASH TEST REPORT

Calspan Report No. 6225-V-16

TEST: TEST NO. 14
TYPE OF TEST: CAR-TO-CAR FRONT-TO-SIDE OBLIQUE
TEST DATE: 22 AUGUST 1979

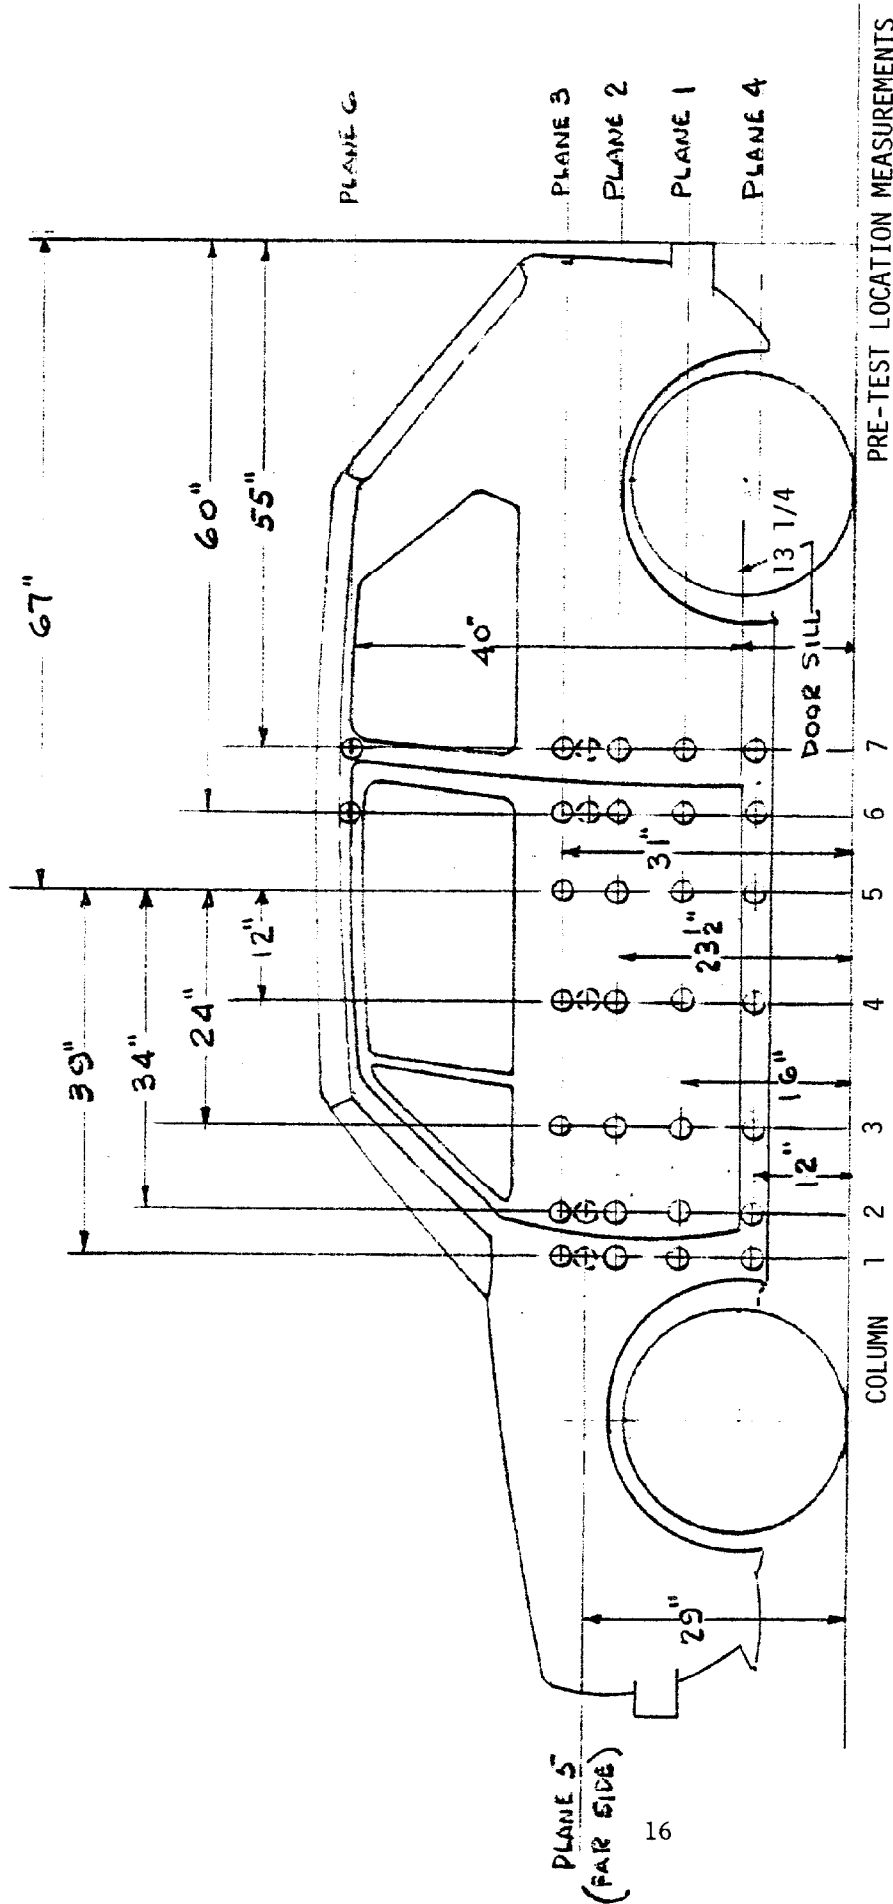
Figure 10 SIDE INTRUSION MEASUREMENT LOCATIONS

DIMENSIONS LISTED BELOW ARE FROM POINTS SHOWN ON FIG. 10 TO REF. PLANES LOCATED PARALLEL TO AND OUTBOARD FROM ϕ OF VEHICLE (L. SIDE 34" - R. SIDE 34")

DIMENSIONS LISTED BELOW ARE MEASURED WITH A ROD THROUGH A 1/8" HOLE AT EACH LOCATION AS SHOWN IN FIGURE 10

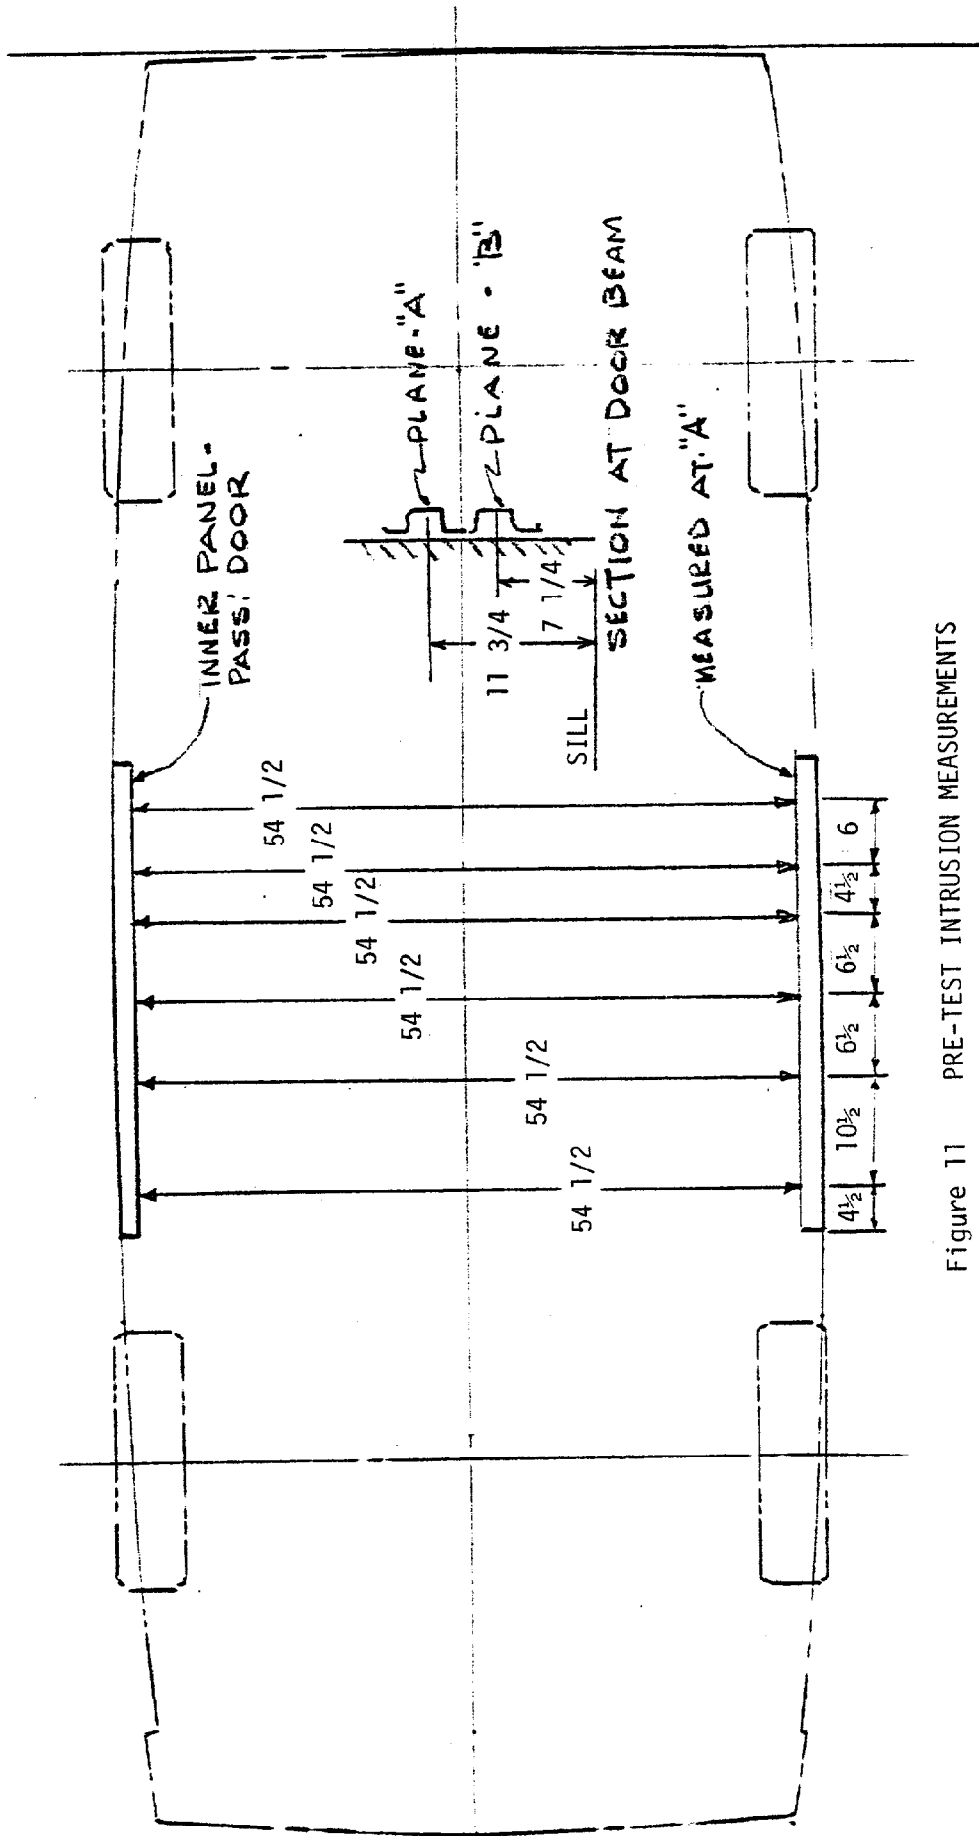
Figure 11 PRE-TEST INTRUSION MEASUREMENTS

PLANE "A"
PRE-TEST #14

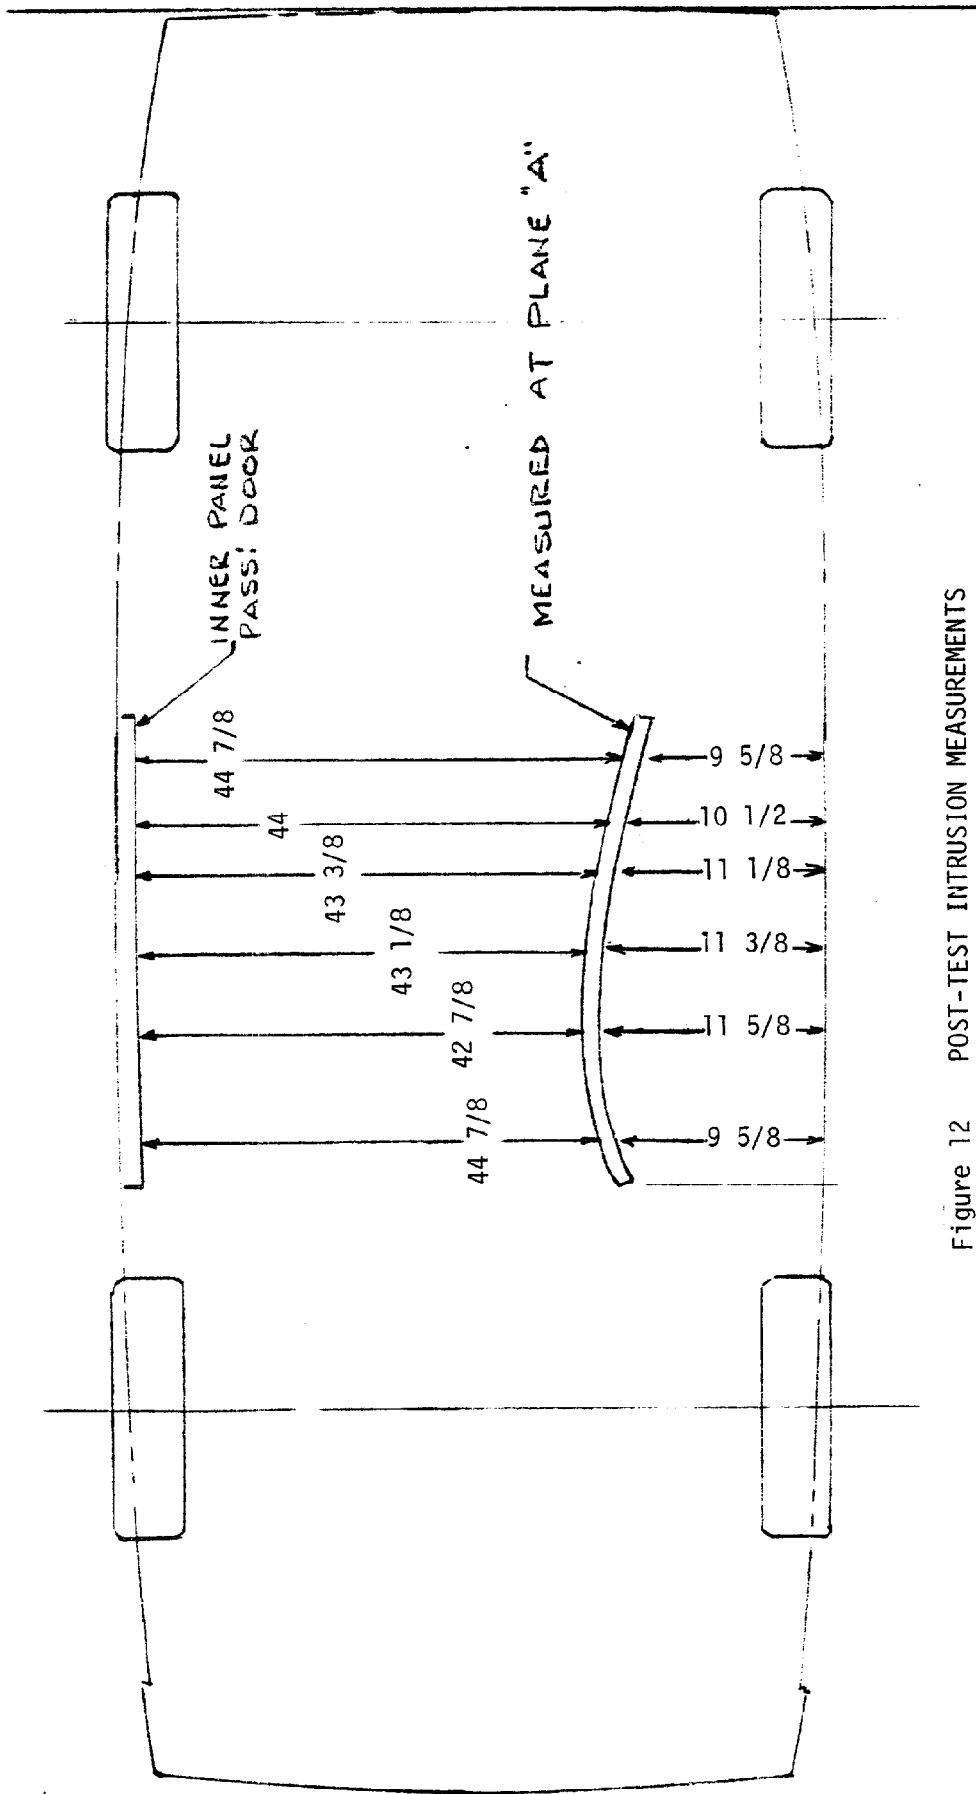
Figure 12 POST-TEST INTRUSION MEASUREMENTS

PLANE "A"
POST-TEST #14

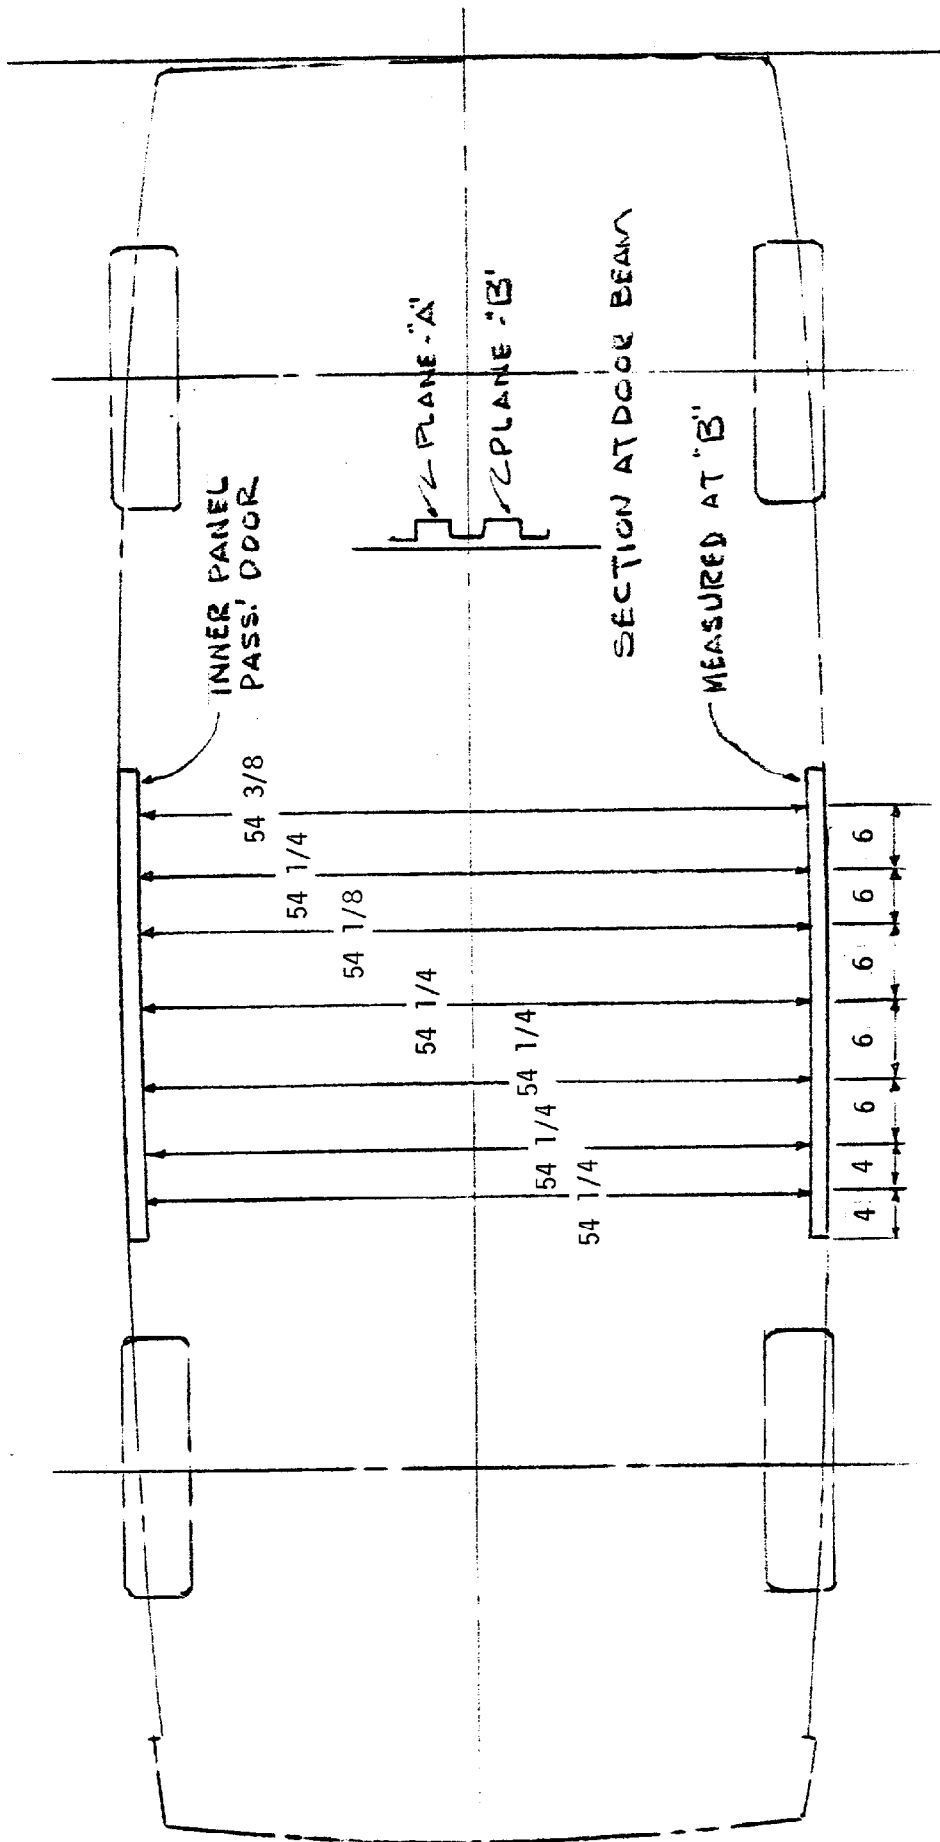
Figure 13 PRE-TEST INTRUSION MEASUREMENTS

PLANE "B"
PRE-TEST #14

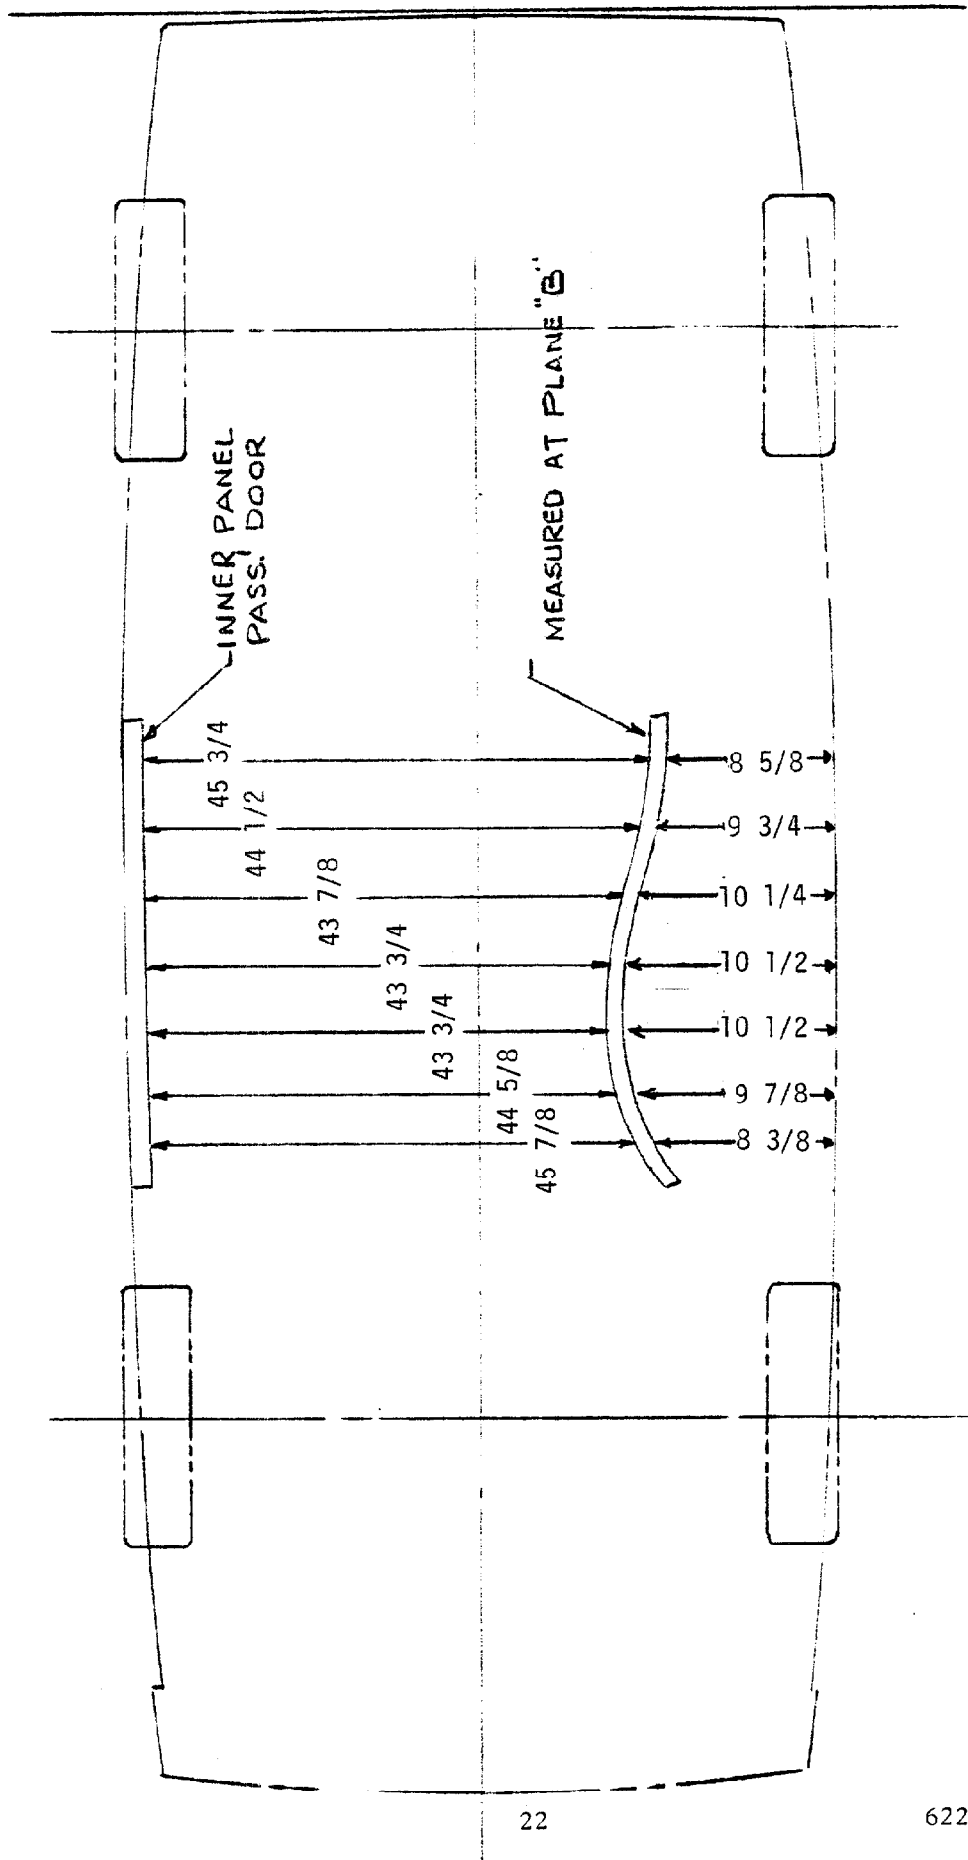
Figure 14 POST-TEST INTRUSION MEASUREMENTS

PLANE "B"
POST-TEST #14
